Human-Induced Changes in Back-Barrier Environments as Factors in Tidal Inlet Instability with Emphasis on Florida

by Richard A. Davis, Jr. and Gary A. Zarillo

PURPOSE: This Coastal and Hydraulics Engineering Technical Note (CHETN) provides general information about the consequences of human alterations of back-barrier environments on tidal inlet stability, including several examples from the gulf coast of peninsular Florida.

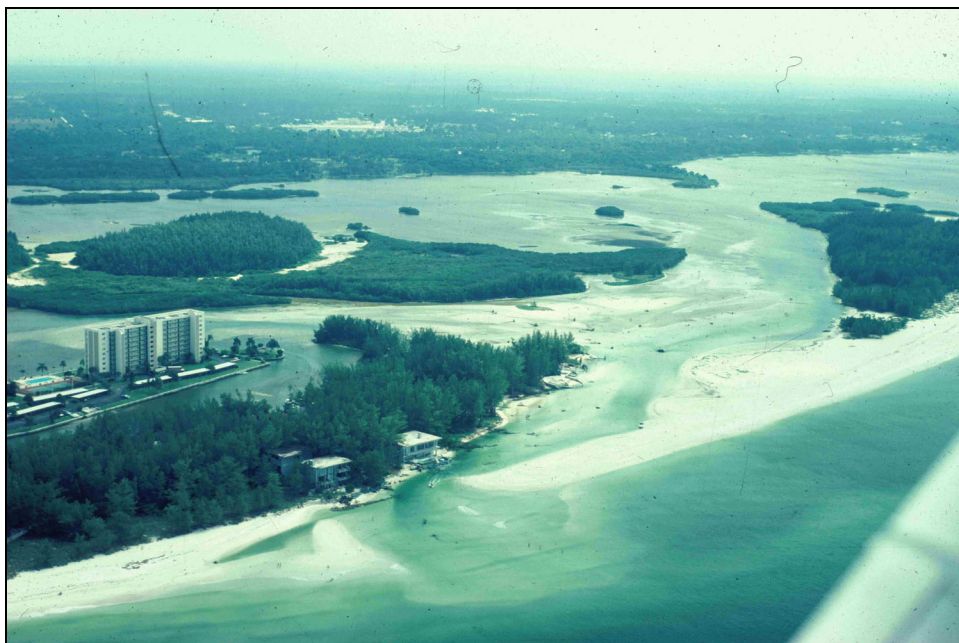
Figure 11. Midnight Pass in 1983 just before closure

This narrow and shallow bay had several elongate oyster reef complexes along its length whose orientation and configuration perpendicular to the shoreline (Figure 11) indicated that at least some tidal currents moved along the length of the bay, and not simply in and out of Midnight Pass. Oysters receive their nourishment from suspension feeding, which means the most efficient organization is to stretch across the currents that are carrying the suspended nutrient material.
